TECH TIP

How About a Little More Brake and a Little Less Shake?

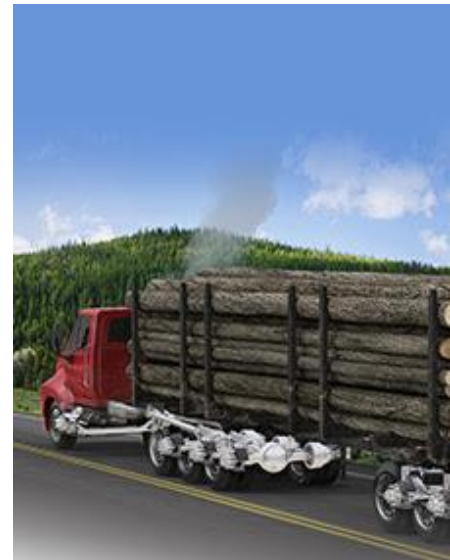
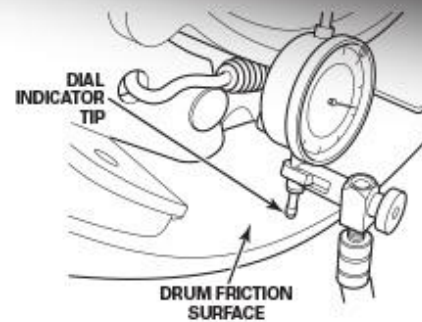
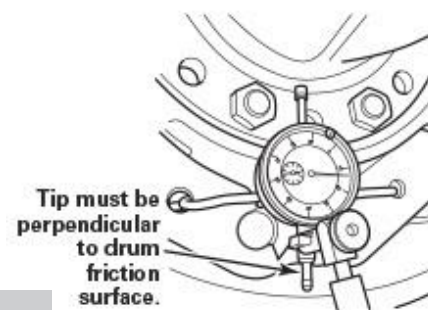
You must check TIR on a brake drum in an assembled brake. Do not disassemble the wheel/tire assembly, brake drum from hub or any other components prior to initial TIR inspection. Disassembly will change the original position of the assembled components and may vary TIR readings/performance.

If assembled TIR exceeds 0.015-inch (0.381 mm):

- Remove the drum and inspect the components. Damaged and corroded hub-to-drum mating surfaces/pilots are becoming a common cause of vibration complaints.
 - Verify wheel bearing adjustment. Wheel bearing end play must be within the required 0.001"-0.005" or be properly preloaded with Dr. Preload or assemble brake TIR will be increased. Excessive end play can cause the drum braking surface to not be concentric to the bearings/spindle.
- If damaged is found, replace the necessary components, re-assemble and verify TIR is within specification
